## Comparison of Geotechnical Investigation Results with Encountered Ground Conditions during Subsea Tunnelling in Qatar

Project Coordinator of Musaimeer Pumping Station and Outfall Project,  
Public Works Authority, Doha, Qatar  
smarri2@ashghal.gov.qa

**Cite as:** Al-Marri S.Z., Peach G. & Hameed F., “Comparison of Geotechnical Investigation Results with Encountered Ground Conditions during Subsea Tunneling in Qatar”, *The 2<sup>nd</sup> International Conference on Civil Infrastructure and Construction (CIC 2023)*, Doha, Qatar, 5-8 February 2023, DOI: <https://doi.org/10.29117/cic.2023.0068>

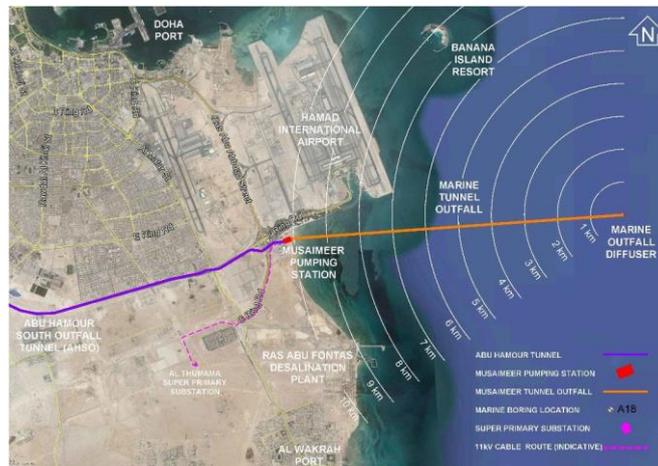
Musaimeer pumping station and outfall project was constructed south of Hammad International Airport, Doha. The project is designed to manage surface and rainwater received from the drainage networks from 270 km<sup>2</sup> of urban areas in southern Doha. It consists of pumping station with pumping capacity of 19.7m<sup>3</sup> per second and 10.2 km long subsea outfall tunnel. The project outline is shown in Figure 1.

**Fig. 1: Project Location**

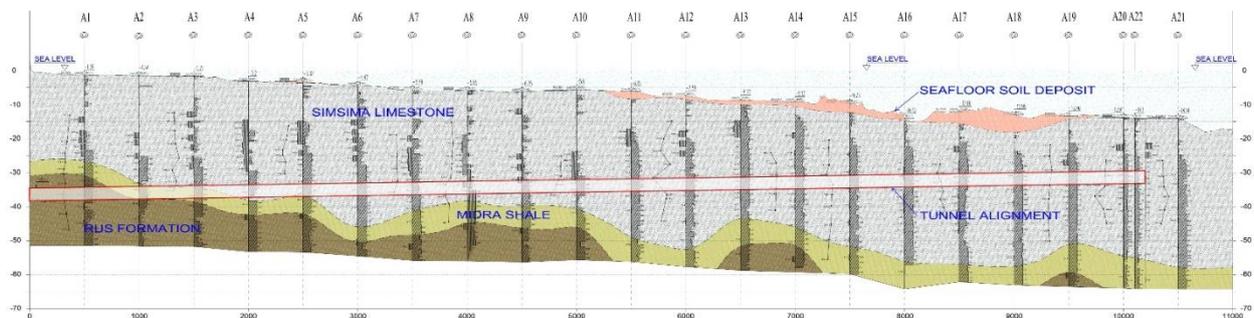
As part of pre-tendered geotechnical investigations, borehole drilling (A1 to A22) and geophysical surveys, including Seismic reflection, Seismic refraction, were performed to access the in-situ ground conditions. Figure 2 shows the tunnel alignment, bore holes and geological formations.

**Fig. 2: Lithological Cross Correlation from drilled boreholes**

Core drilling was carried out along the tunnel alignment by 22 marine boreholes, 50 m in depth and 500 m apart from each other along the tunnel alignment. The rock stratigraphic units encountered were identified as made ground, unconsolidated soil, Simsima limestone, Midra Shale and Rus formation.

The characteristics of these geological units were poor bedding structures oriented in horizontal to sub-horizontal as cross-correlated from all the boreholes findings. There was no evidence of active faulting across the lithological units. Jointing systems indicated the predominant development of horizontal to sub-horizontal joint sets in the project area. The characteristics of stratigraphic units of the project are described as follows.

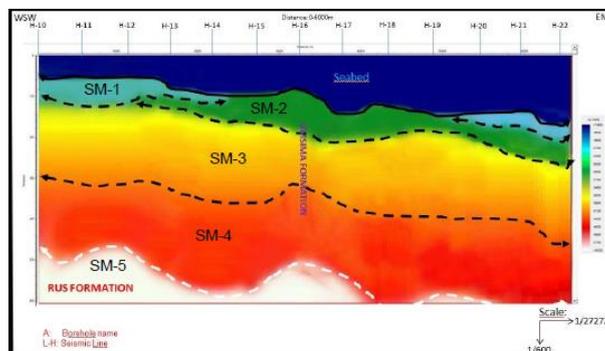
Generally, four to five different seismic mediums (SM) were determined. SM-1 (Weak Limestone) started first 5m-10m from the sea floor and velocity range  $V_p=1600-2250\text{m/s}$ , SM-2 (Weak to medium strong Limestone) between 10m-20m,  $V_p= 2250-3400\text{ m/s}$ , SM-3 (Medium Strong to Strong Lime Stone) between 20m to 30 m and  $V_p= 4100-4900\text{ m/s}$ , SM-4 (Strong to very strong Limestone) between 30m-50m,  $V_p=4100-4900\text{ m/s}$ . Values of  $V_p=4900-5400\text{ m/s}$  were also recorded which were considered as compact material. Figure 4 shows a typical Seismic velocity section.

Fig. 4: Seismic velocity section

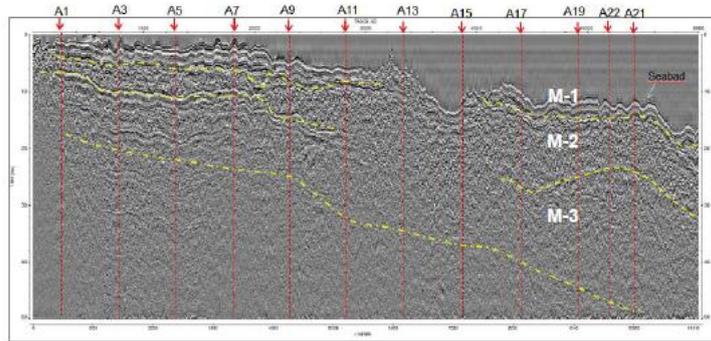
Seismic reflection data was well matched with seismic refraction and core drilling results. Three seismic mediums M1, M2, M3 were observed. Figure 5 shows a typical seismic reflection survey result.

**Fig. 5:** Cross section of seismic reflection

Seismic refraction and reflection sections are in harmony with each other. Depth and thickness of layer for seismic reflection cross section were calculated based on thickness of layer obtained from seismic refraction for time to depth conversion. Seismic interpretations were made by the developed cross sections. The thickness of the layers was correlated with drilling logs. The yellow lines in Figures 5 & 6 represent the layers from reflection anomalies.

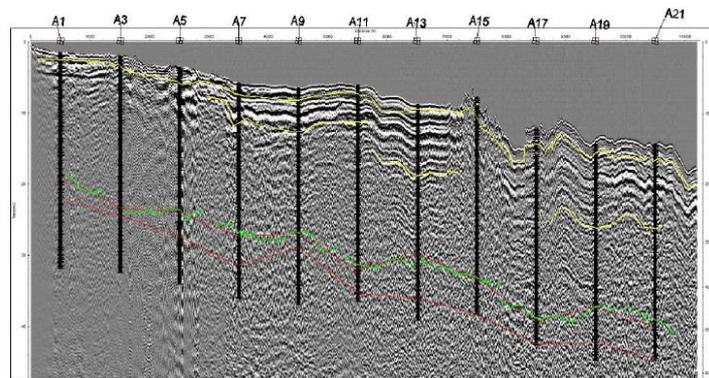
**Fig. 6:** Seismic reflection cross section and boreholes

Generally, two units were determined, Sismsima limestone and Rus formation. In addition, from time to time at different depths, thin Midra shale, mudstone layers were detected in bands. Interpretation of pre and post tender investigations result in the identification of 20 anomalies of note classified as F1 to F20.

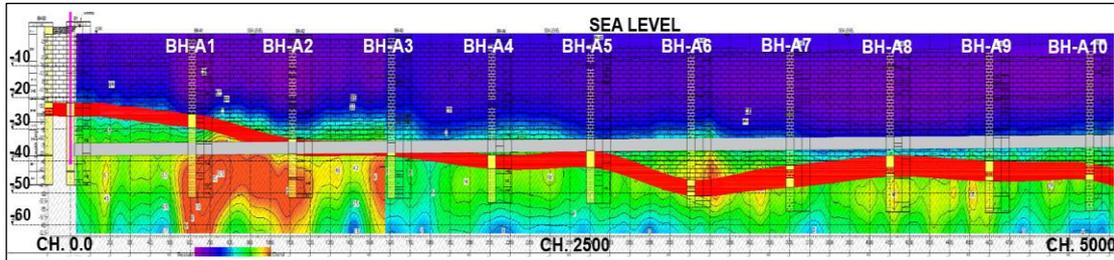
The area between 7.6 to 8 km was also considered an anomalous area. The evidence of a drop of resistivity values of more than 10 ohm-m along the tunnel alignment, was a warning of increasing permeability, and possible hydrostatic connection to the seabed. Figure 8 shows ERT for the entire tunnel alignment.

Fig. 8: ERT line from 0 to 10.2 km

Electric resistivity tomography (ERT) was performed at post tendered stage along the entire tunnel alignment. Several conductive anomalies and resistive anomalies were detected during the first 2km of the survey. The final phase of study confirmed that those anomalies were probably connected to fractures or fracturing systems. Distances along the tunnel alignment start at zero at the pump station and increase to 10.2km at the end of the outfall tunnel

The resistive anomalies are associated to possible different nature and geological risks, however only the one between chainage 6.7 and 6.9 km at depth greater than 50.0 m, could be associated to a possible karstic risk (cavity). However, the tunnel alignment was above that anomaly. The area

between 5.2 to 7.4 km was affected by a significant increasing degree of fracturing and was considered as potential high permeability zone.

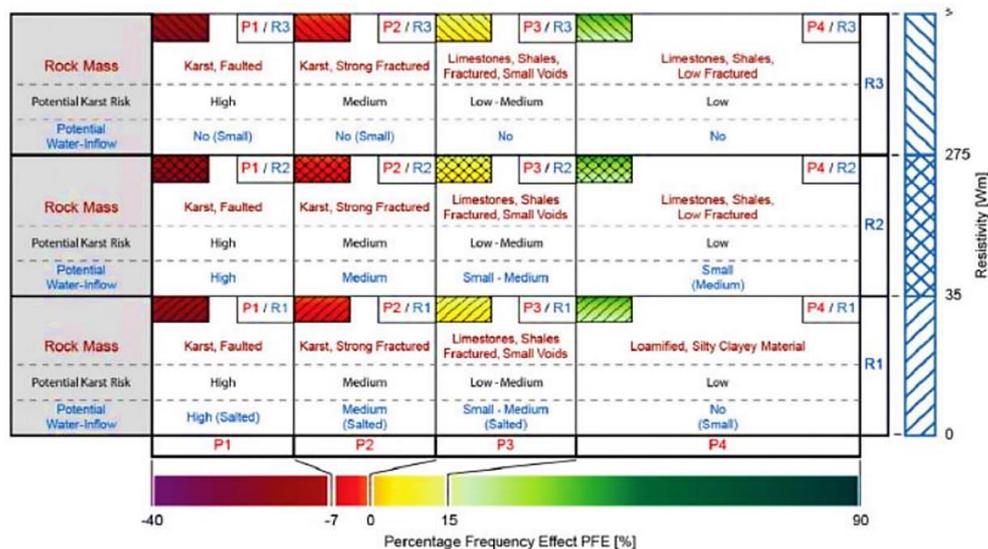
The interpretation of the matrix, which is shown in Figure 9, is based on the columns and rows; factors on the columns refer to the karst interpretation (P1:P4) while factors on the rows (R3:R1) refer to the possibility of water inflow.

Fig. 9: BEAM Interpretation Matrix

The TBM was equipped with Bored Tunnelling Electric Ahead Meter (BEAM) system, which is a non-intrusive electrically induced polarization system able to predict ground conditions up to 12 m ahead. Information is displayed in a matrix which combines resistivity and percentage frequency effect (PFE).

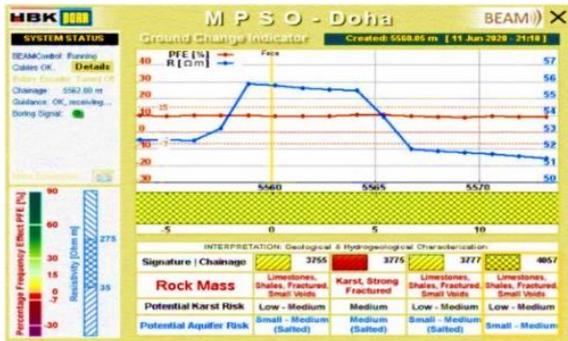
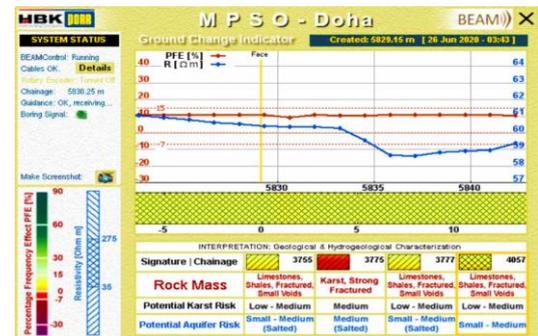
In Figure 10 the bored tunnelling electric ahead meter (BEAM) display indicates the results of crossing two anomaly zones identified by the post tender geotechnical surveys.

(a): Fault zone F10

(b): Fault zone F13

Fig. 10: BEAM Display at Fault zone F10 – F13

It is important to note that there are limitations on the precision accuracy of the system. The system is not able to identify whether the TBM is passing through Rus formation, Midra Shale or Simsima limestone; it can only identify intrinsic properties of rock mass. It is not possible to measure the exact amount of water inflow and location. The system can provide an estimation of the possibility that water inflow or aquifers might be encountered.
